# Above the Flood: Elevating Your Floodprone House

FEMA 347/ May 2000

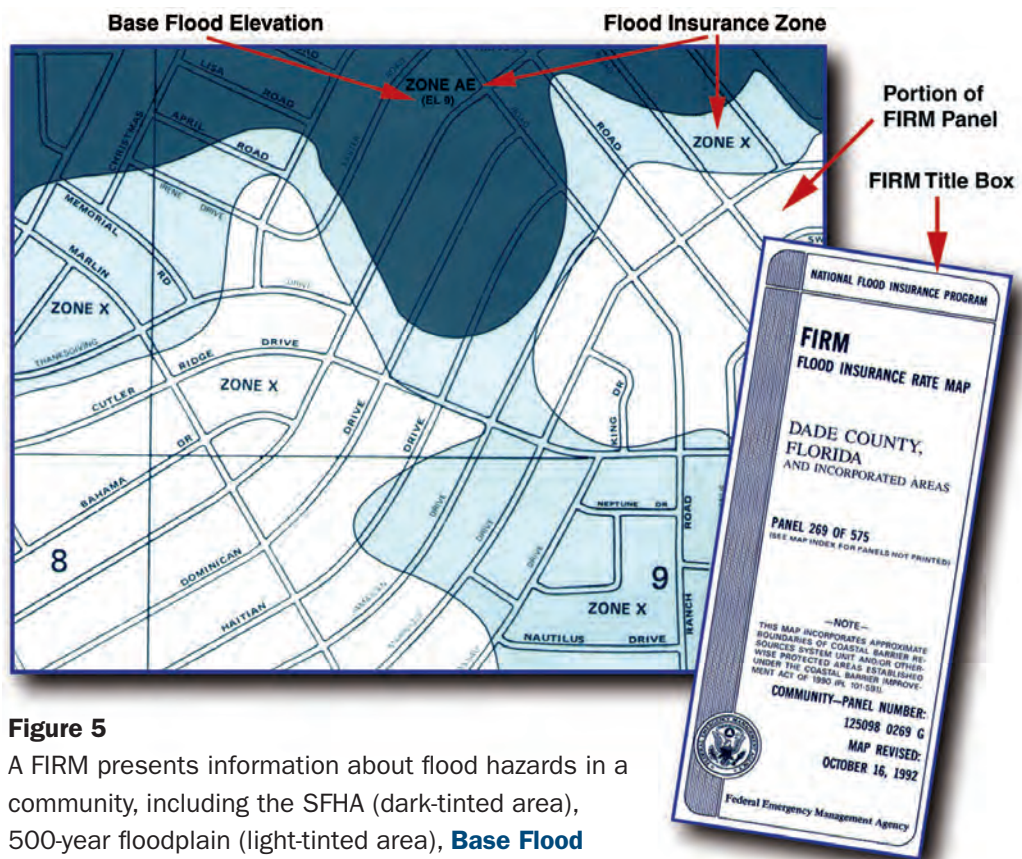
**Figure 5**

A FIRM presents information about flood hazards in a community, including the SFHA (dark-tinted area), 500-year floodplain (light-tinted area), **Base Flood Elevations**, (BFEs) (number in parentheses), and flood insurance zones (AE and X in this example).

Note that the SFHA in the example in Figure 5 is designated Zone AE. This zone is only one of several applied to SFHAs under the NFIP, including V, VE, V1-V30, A, AE, A1-A30, AO, and AH. These zones indicate differences in the types and severity of flood hazards in SFHAs. For the purposes of this publication, it is sufficient to focus on the basic differences between the two main types of SFHA zones—V zones and A zones. The distinction is important because regulatory requirements associated with V zones and A zones differ significantly. As explained later in this chapter, these requirements affect the types of building elevation techniques that may be used under the NFIP.

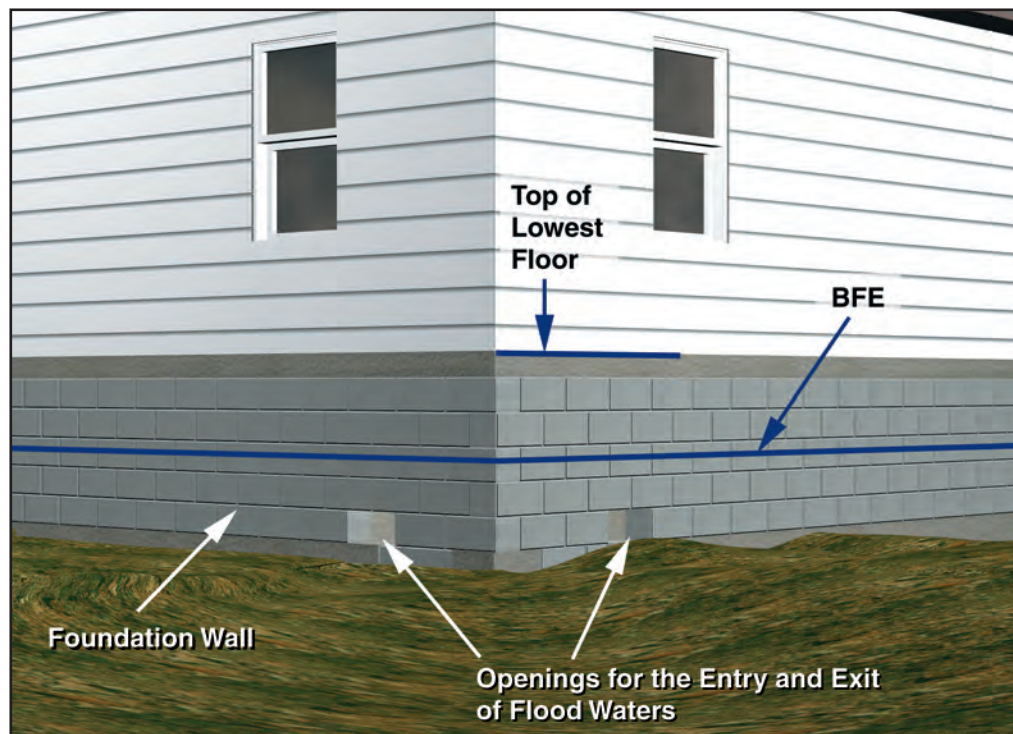
**Figure 6**

In a new, substantially improved, or substantially damaged building in an A zone, the elevation of the lowest floor must be at or above the BFE.

In A zones, where flood hazards are less severe, buildings may be elevated either on an open foundation or on continuous foundation walls below the BFE (Figure 6). Regardless of the type of foundation used, A-zone buildings must be elevated so that the **lowest floor** is at or above the BFE, as shown in Figure 6. If continuous walls are used below the BFE, they must be equipped with openings that allow flood waters to flow into and out of the area enclosed by the walls (Figure 6). Allowing the entry and exit of flood waters ensures that water pressures will be the same on both sides of the walls and reduces the likelihood that water pressure will cause the walls to fail.

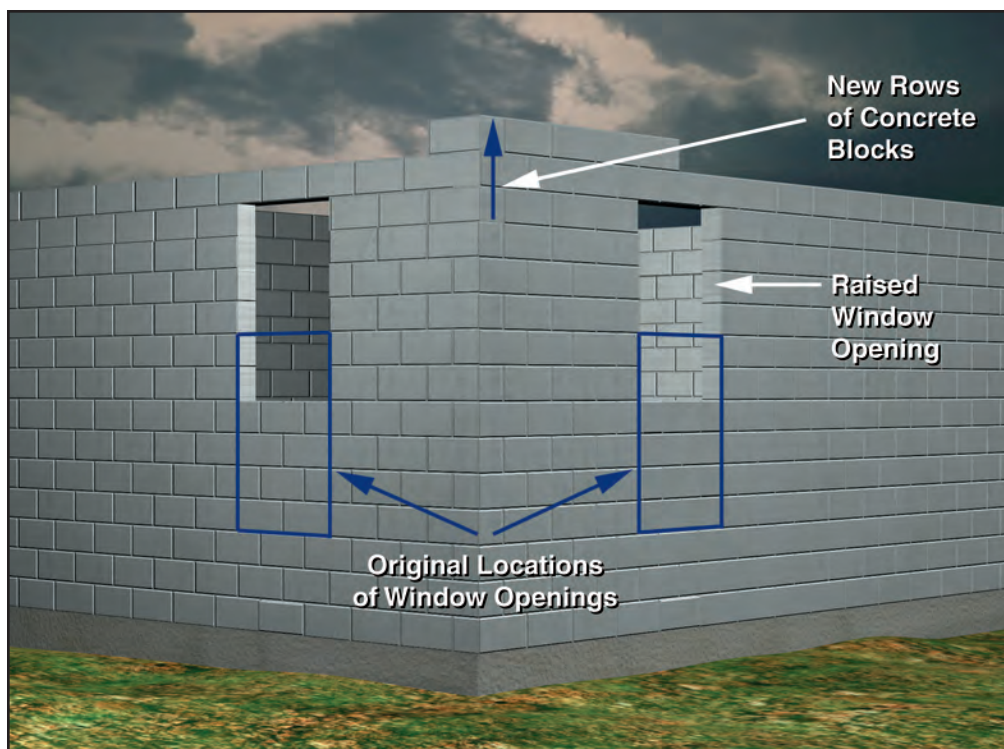
The tops of the walls and bottoms of the window openings are raised with concrete blocks.

After the roof, windows, and doors are removed, several courses of concrete block are added to the tops of the existing walls and to the bottoms of the window openings (Figure 11). A corresponding number of blocks are removed from the tops of the window openings so that the size of the windows will remain the same. In addition, although not shown in Figure 11, concrete bond beams are formed in place at the tops of the extended walls to provide structural reinforcement.

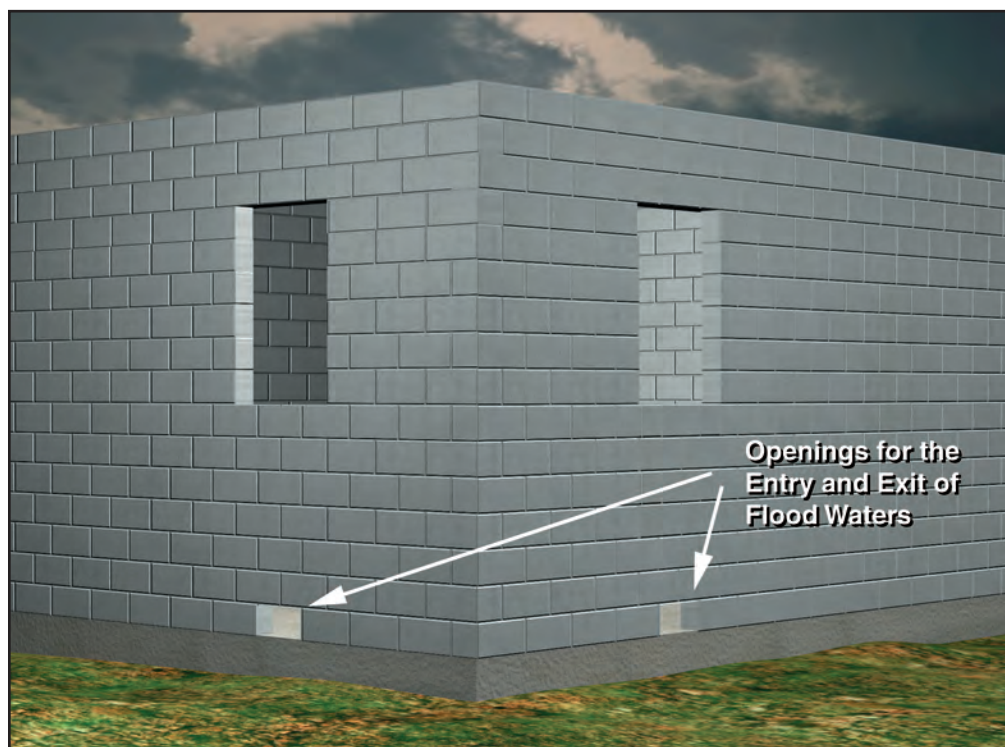
**Figure 12**  
Openings are created  
in the walls near the  
ground.

Blocks are removed from the walls of the house at selected locations within 1 foot of the ground (Figure 12). The resulting openings will allow flood waters to flow into and out of the lower area of the house so that the water pressures on both sides of the walls will remain the same. The roof and windows are then replaced, and a new wood-frame floor is constructed above the flood level (Figure 13).

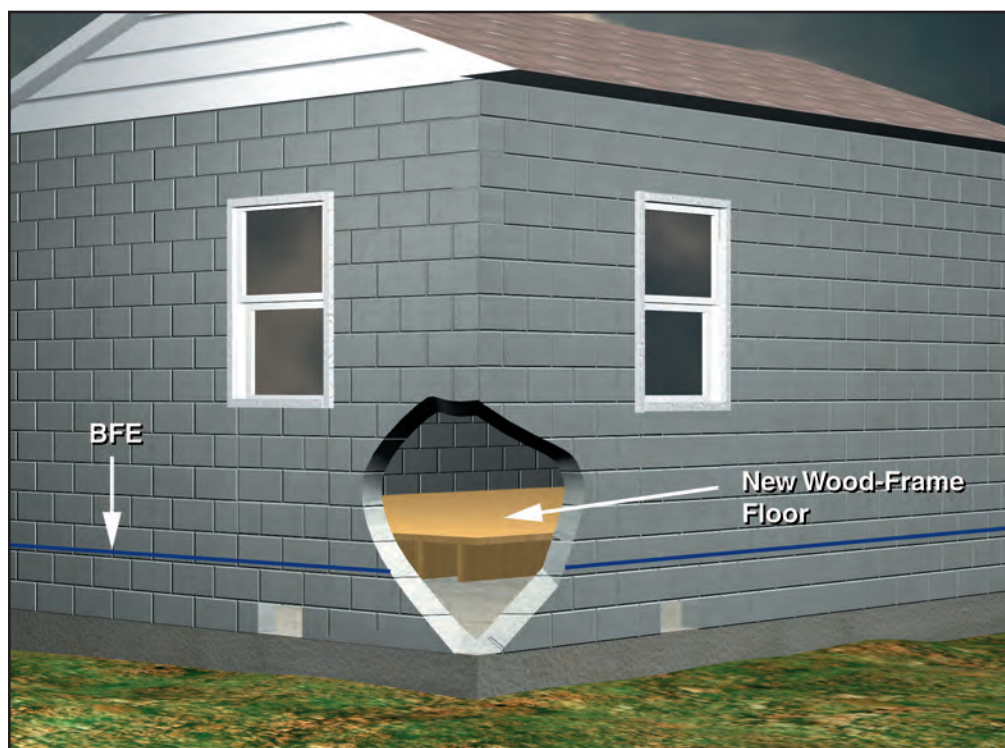
**Figure 13**  
A new wood-frame  
lowest floor is  
constructed above the  
flood level, and the  
roof, windows, and  
doors are reinstalled.

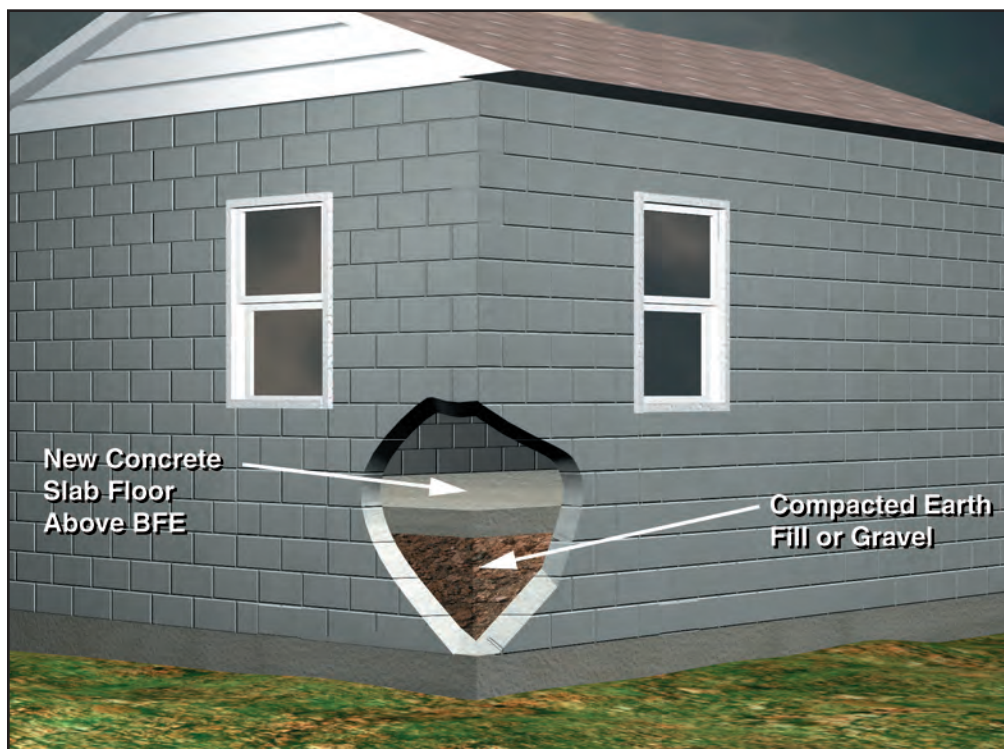
**Figure 14**  
An alternative to building an elevated wood-frame floor is installing a new, elevated concrete slab floor on fill placed over the old slab.

A homeowner who chooses Technique 1 may decide to build a new concrete slab floor instead of a wood floor (Figure 14). When this option is chosen, compacted fill dirt or gravel is placed on top of the old slab and the new slab floor is poured on top. Because the area below the new floor is filled with dirt or gravel, wall openings are not required.

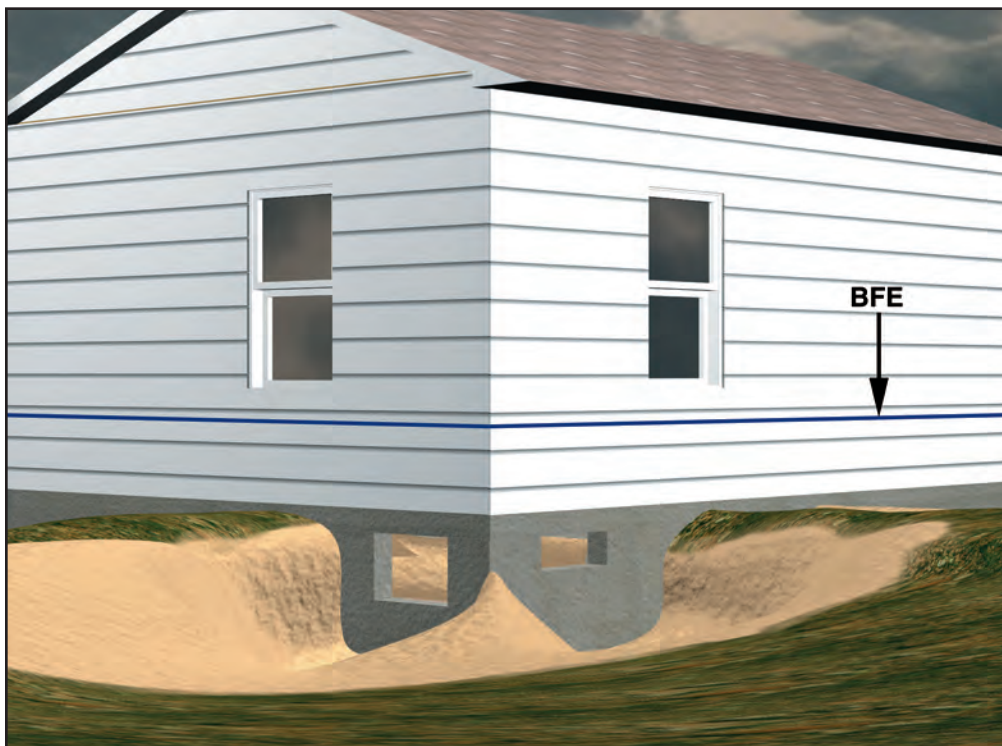
**Figure 17**  
Trenches and tunnels under the slab provide access for the jacks and I-beams that will lift the house.

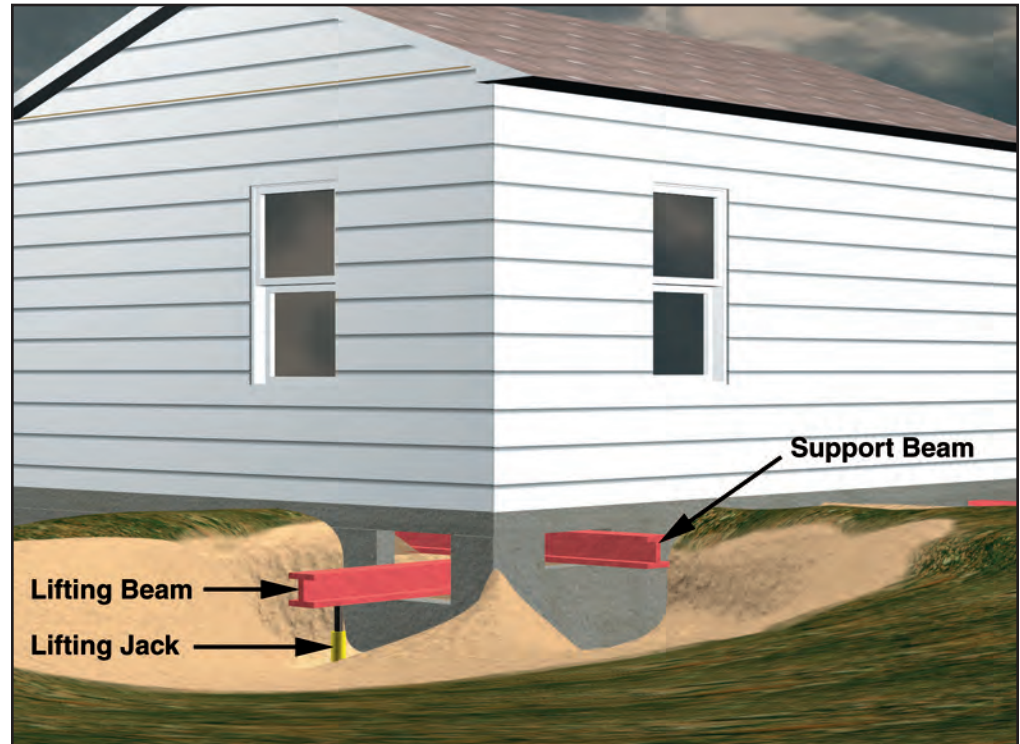
**Figure 18**  
With I-beams and jacks in place, the house is ready to be lifted.

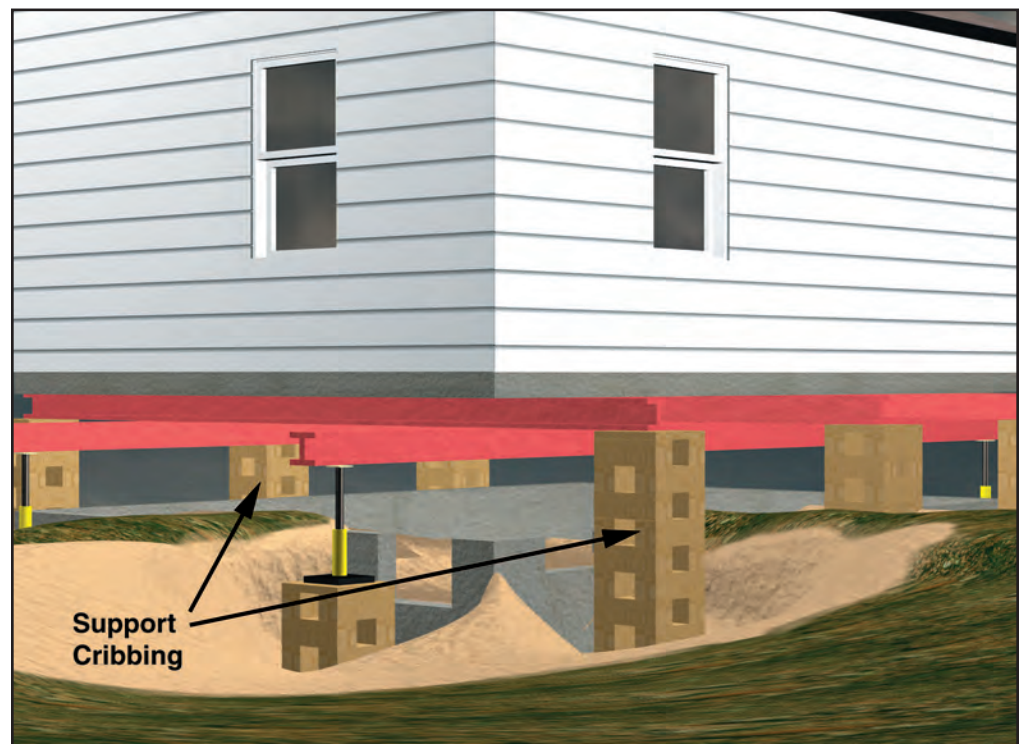
**Figure 19**  
The house is temporarily supported on cribbing.

The house is then jacked up. When the jacks have extended as far as possible, the house must be supported temporarily while the jacks are raised. Both the house and the jacks are usually supported on “cribbing”—temporary piles of crisscrossed timbers (Figure 19). The jacks are then used to raise the house higher.

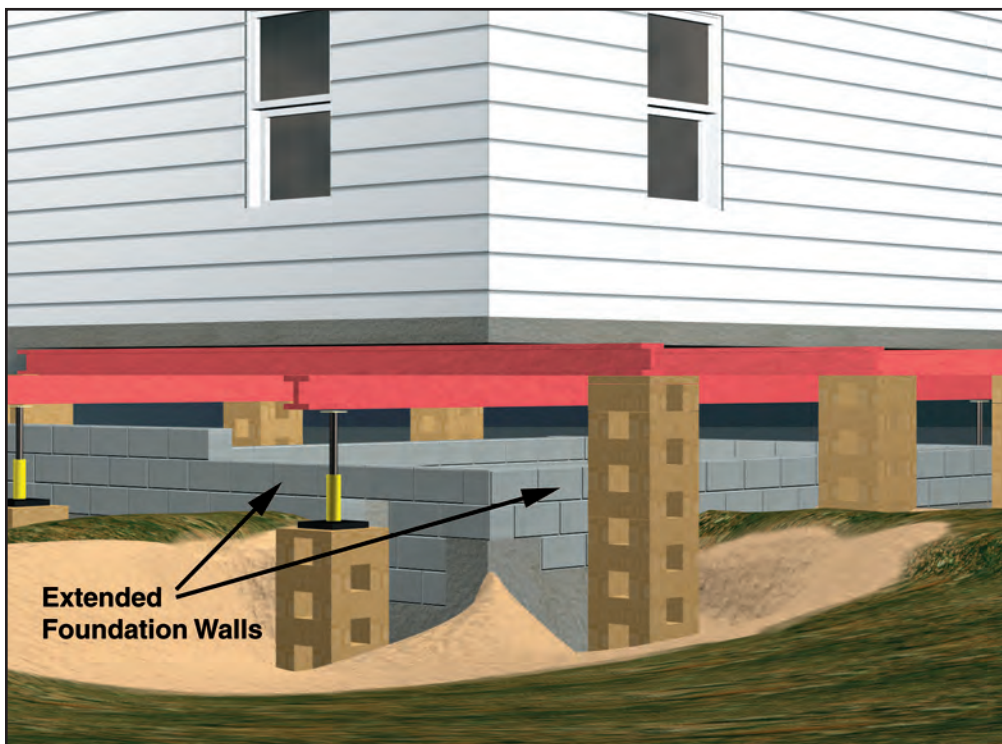
**Figure 20**  
New, extended  
foundation walls are  
constructed with  
concrete blocks.

This process is repeated until the house is raised to the desired height. The foundation walls are then extended upward with additional rows of concrete block (Figure 20). As in the previous techniques, openings are made in the walls within 1 foot of the ground so that flood waters will be able to flow into and out of the area below the elevated floor. The jacks and beams are removed, and the openings left around the beams are filled with blocks (Figure 21).

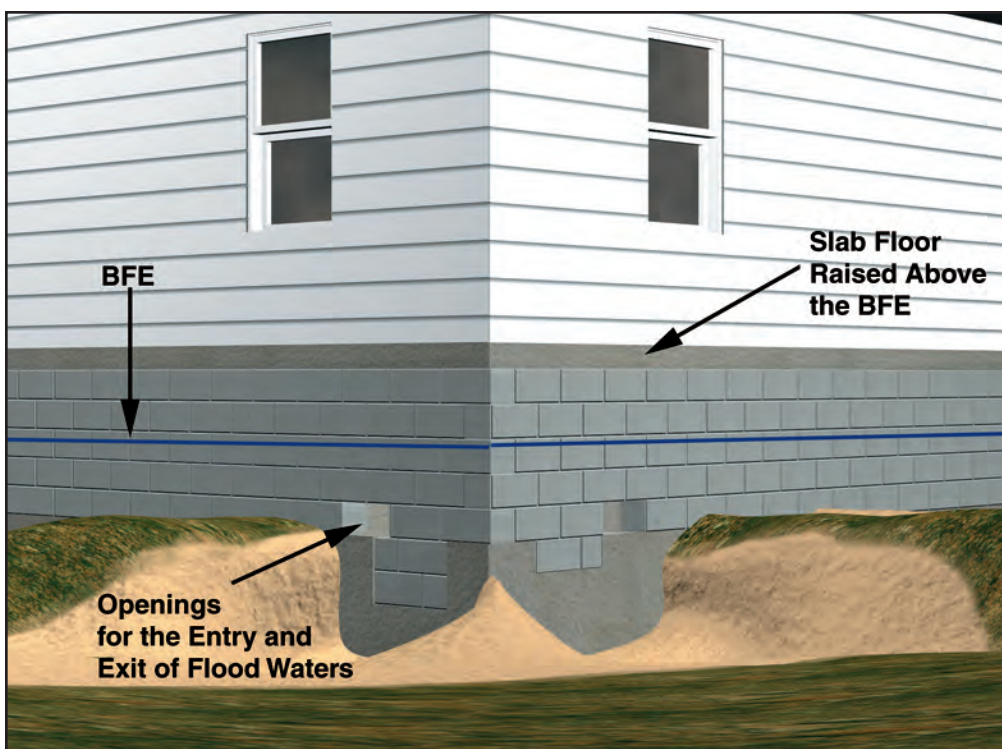
**Figure 21**  
Elevated house and  
slab on new, extended  
foundation walls.

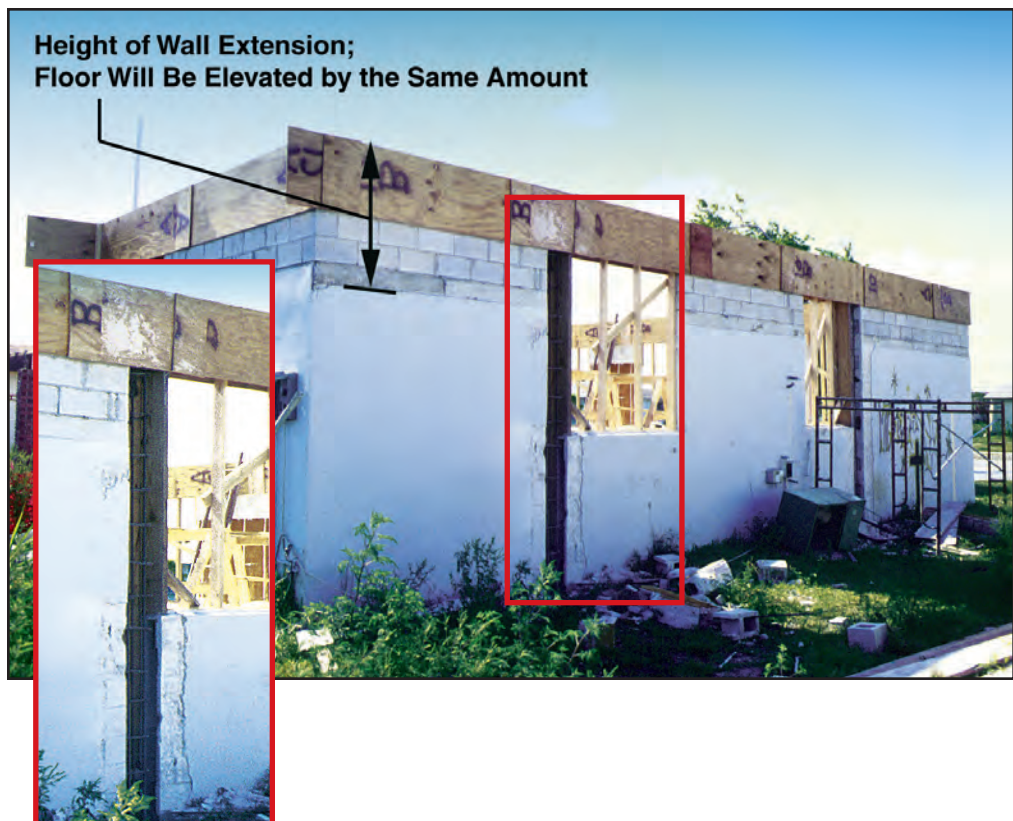
Another view of the extended walls. The vertical cuts in the walls next to the windows are for concrete tiedown columns that will be cast in place to further strengthen the extended walls against wind loads. The owner of this house was able to meet the elevation requirement by raising the floor only a few feet, as indicated by the amount that the walls have been extended.

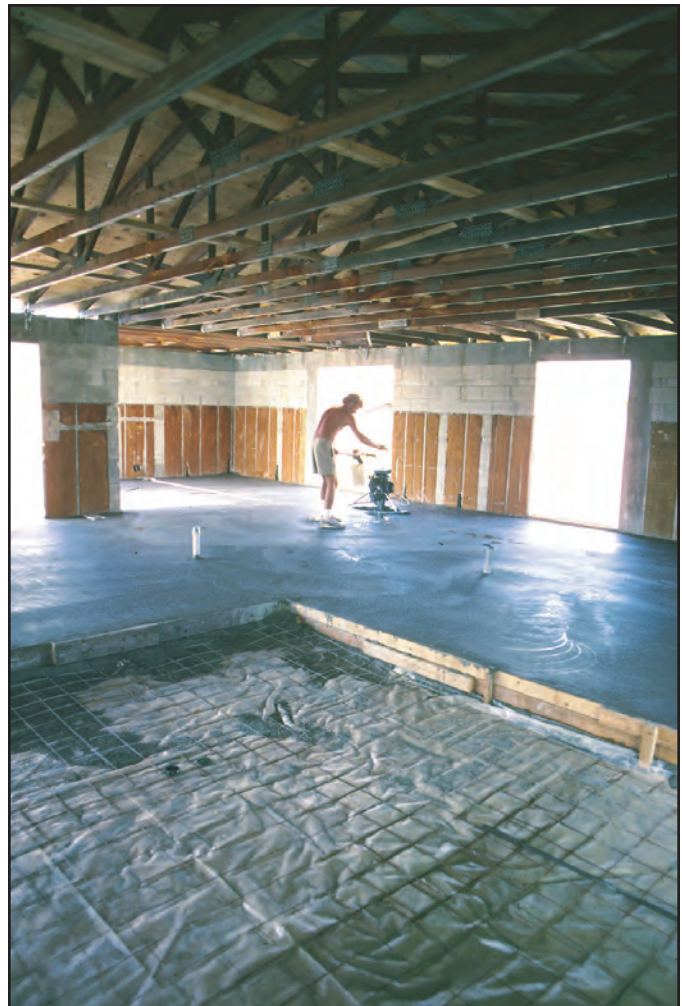
**Figure 26**

The roof has been rebuilt with the salvaged trusses, and most of the new concrete slab has been poured on top of the sand fill. The open area in the foreground, where plastic sheeting and wire reinforcement can be seen on top of the sand fill, is where the remaining part of the slab will be poured.

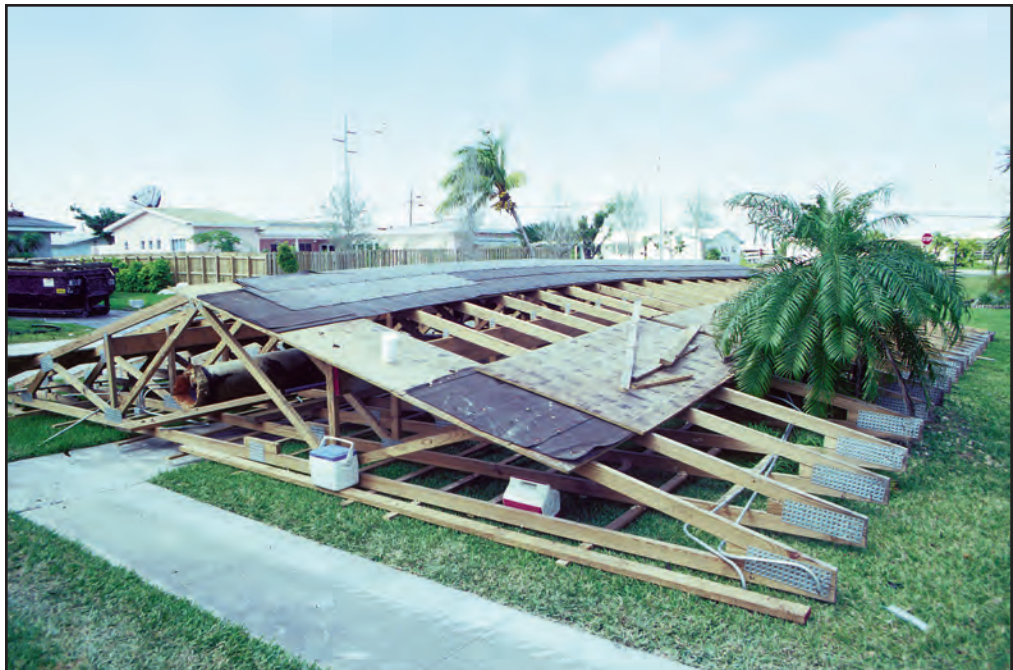
The roof of this house was removed as a single piece; the trusses were held together with bracing and portions of the original roof sheathing. This approach made it easier to reinstall the roof at the end of the project.

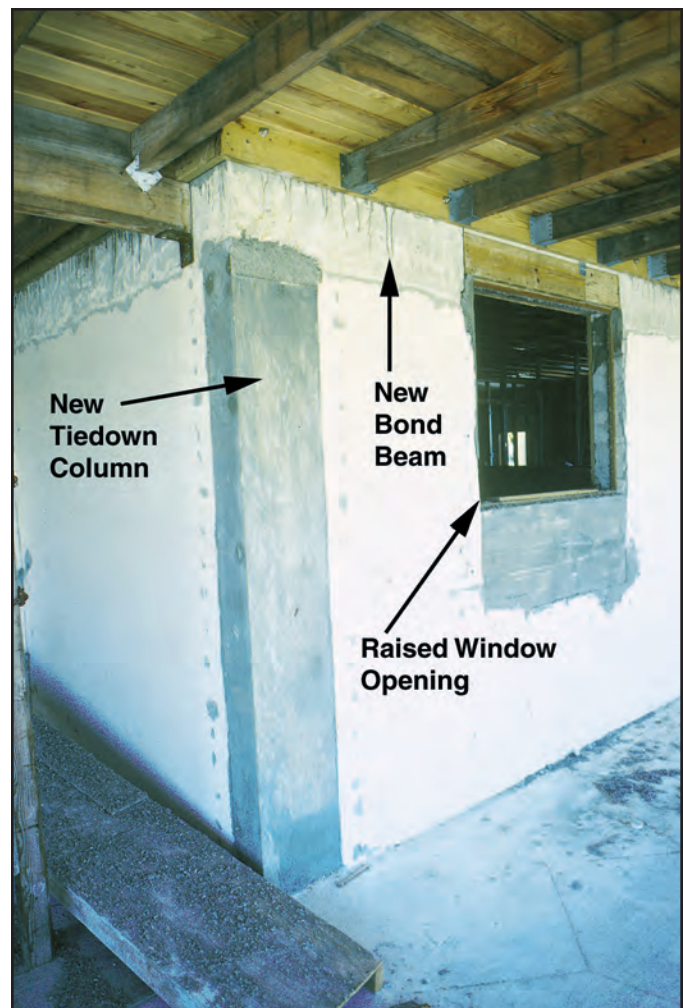
**Figure 41**

Note the new bond beam at the top of the extended wall, the new concrete tiedown column at the corner, and the raised window opening.

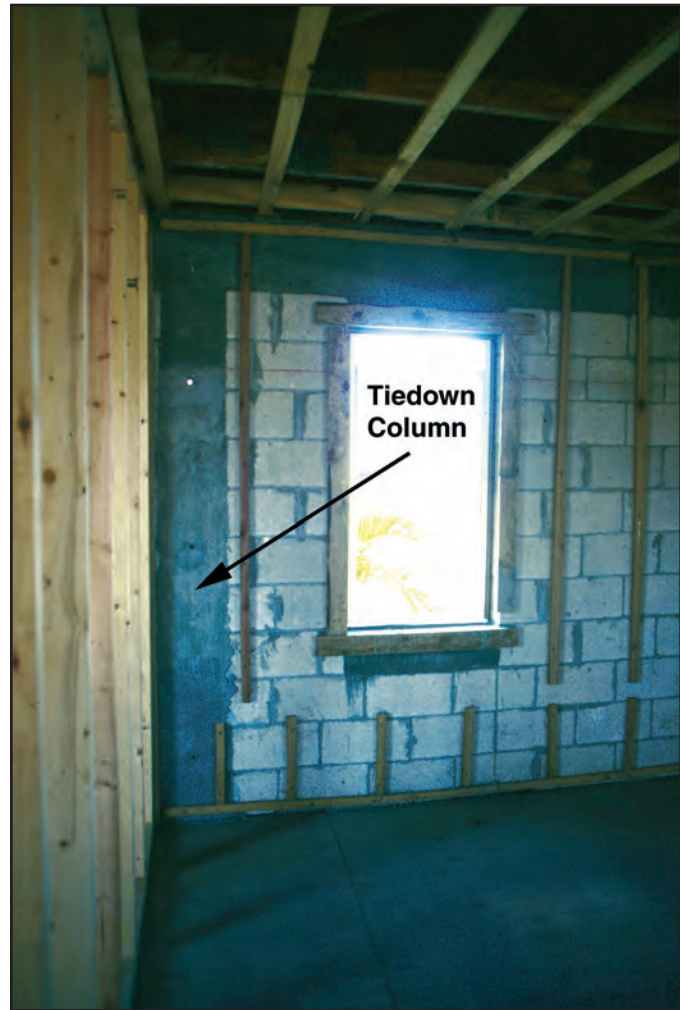
**Figure 46**  
Concrete tiedown columns, such as the one to the left of the window in this photograph, were also used in this house.

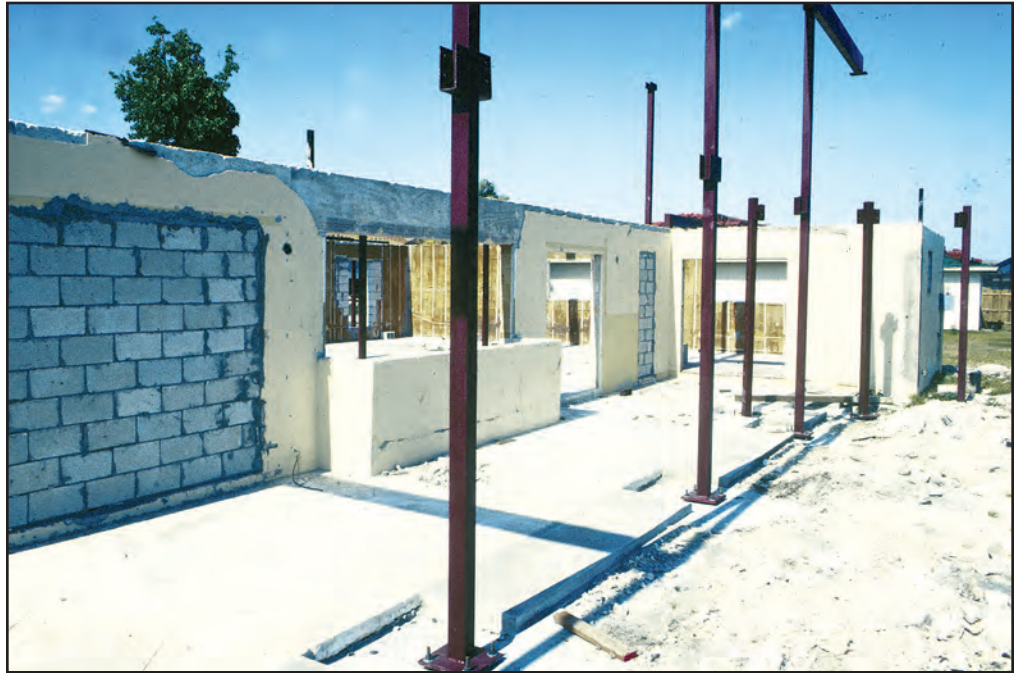
**Figure 52**

The existing first-story walls have been strengthened by the addition of concrete block. Metal columns and beams have been added to help support the new second story.

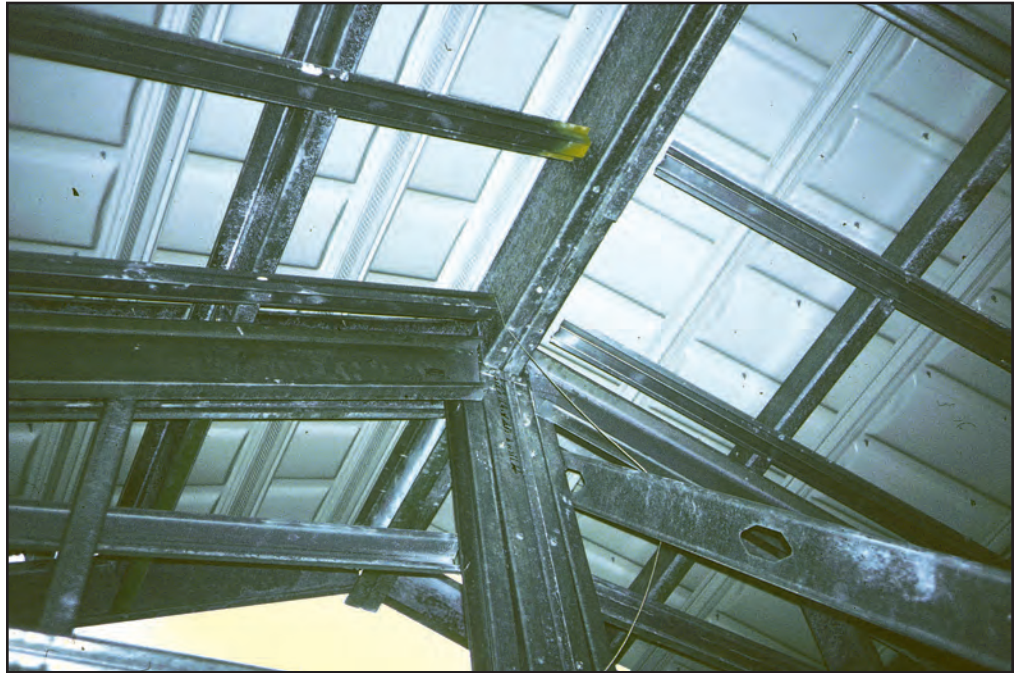
One advantage of metal framing is its relatively light weight. An additional advantage is that the screws used to attach metal-frame components provide strong connections.

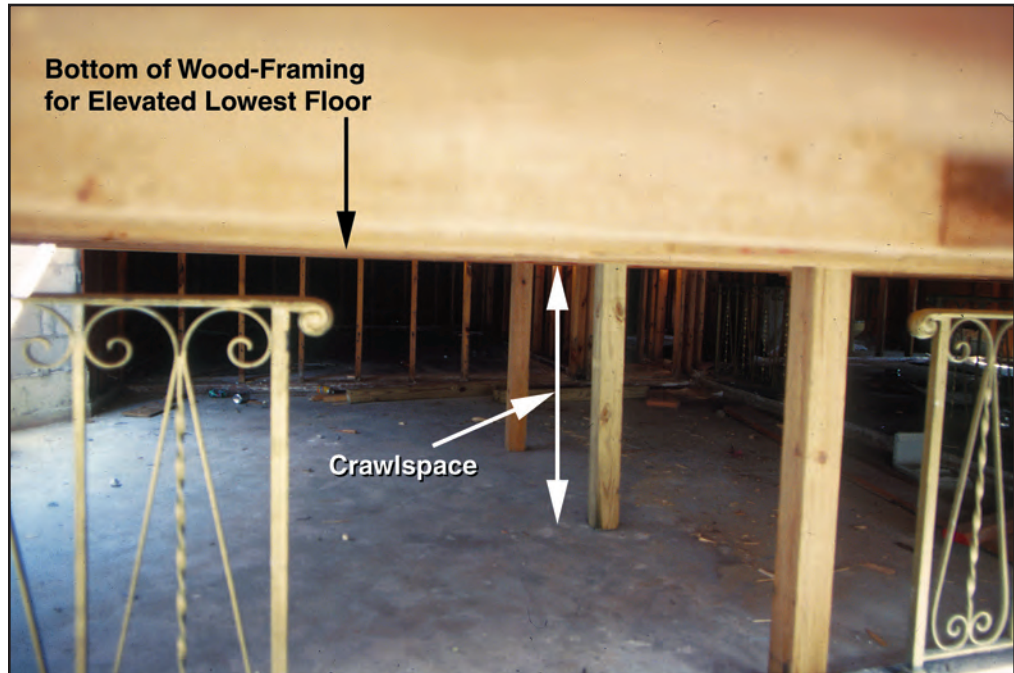
**Figure 68**

Rather than install a new concrete slab on compacted fill, the owner of this house chose to build a new wood-frame floor above the old concrete slab. This method creates a crawlspace below the new floor.

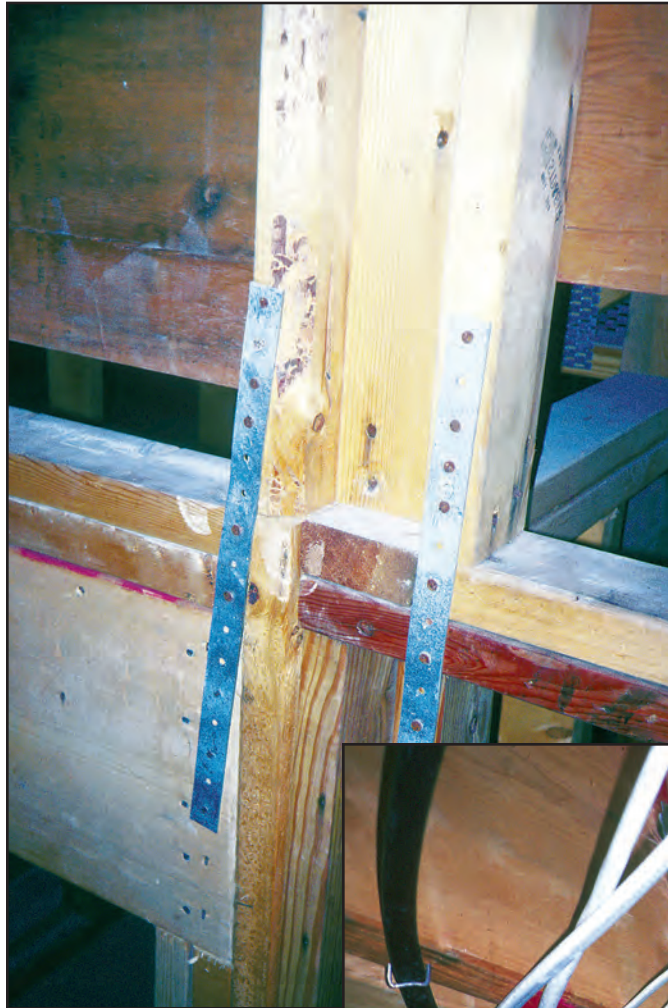
**Figure 70**

Metal hurricane straps are used to tie the structural members together and create a continuous load path from the roof to the foundation.

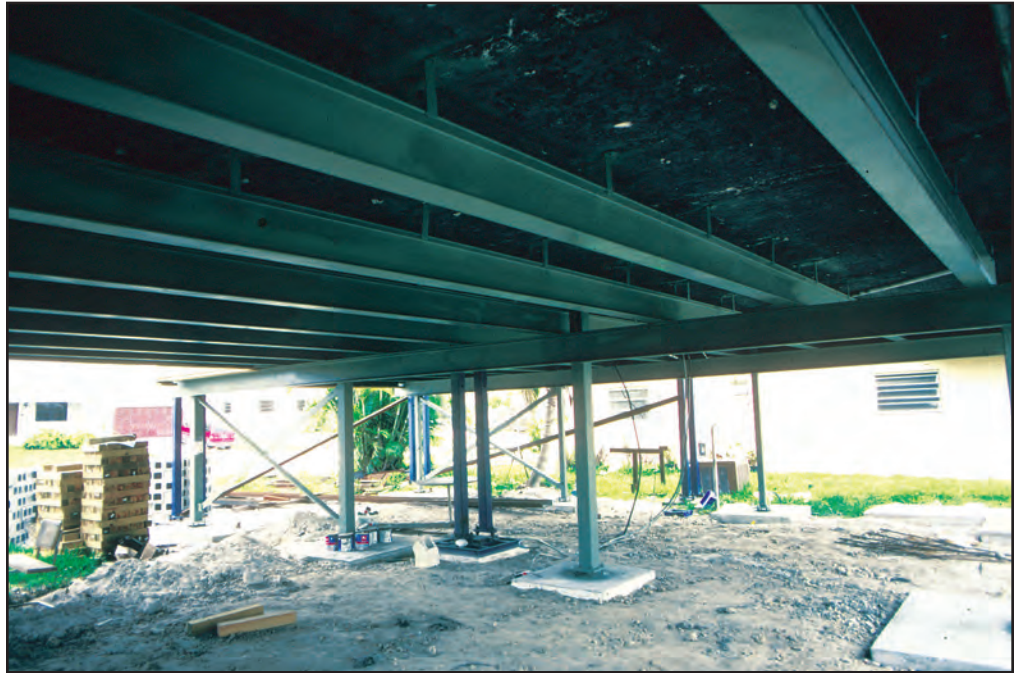
**Figure 82**

While the jacks and beams supported the house, new steel foundation members were installed below.
